## Enhanced Preliminary Assessment Report:

### Westport Army Housing Units Westport, Connecticut

October 1989

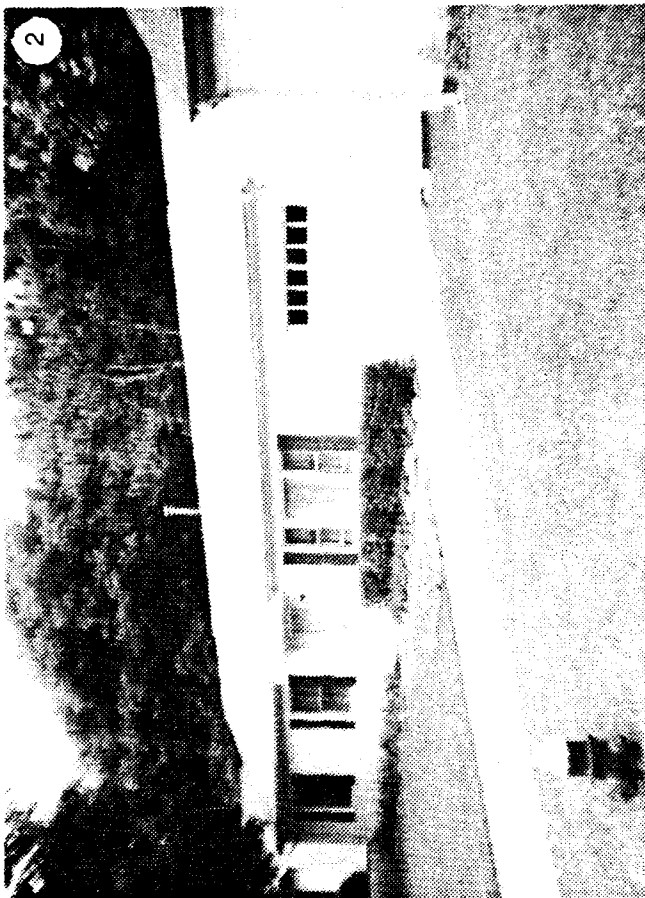
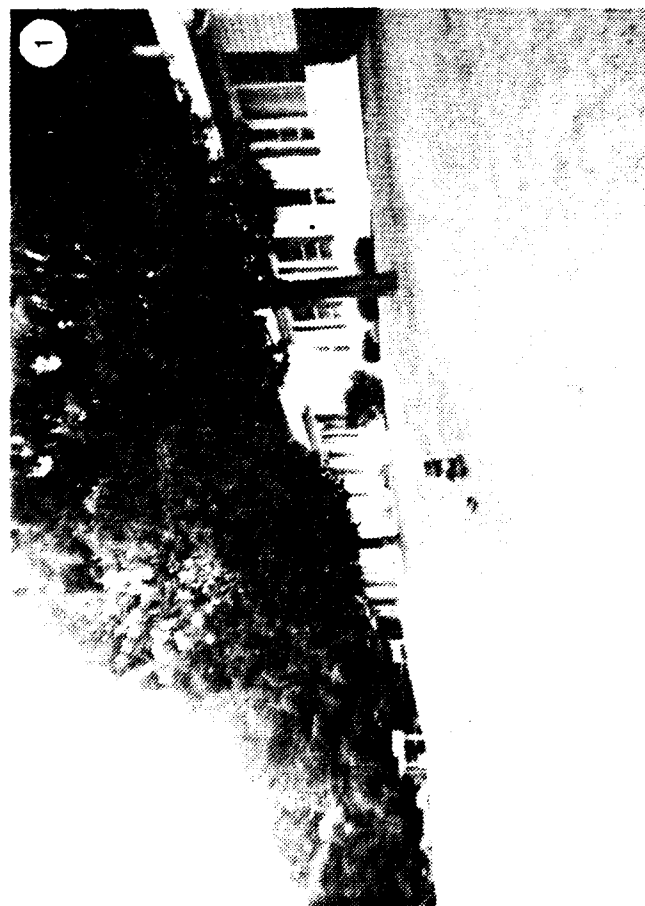
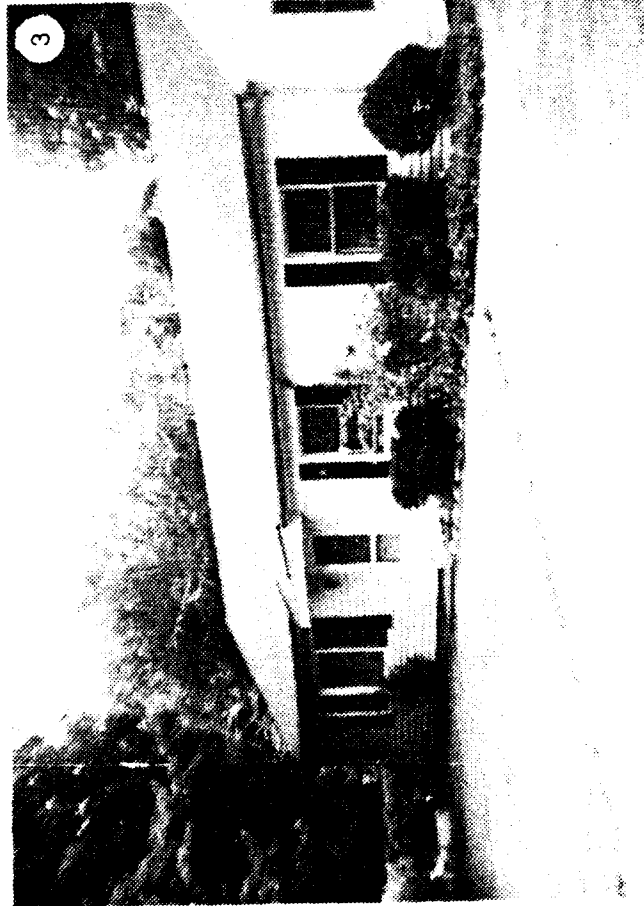
1. A view westward along Wassell Lane; note the broken cap on the water-gate pipe stem in front of the fire hydrant; housing unit #6 is in the foreground.
2. Housing unit #18, one of five units with an attached garage.
3. One of the 11 units without an attached garage.
4. An electrical transformer atop a utility pole; the three transformers on site are maintained and repaired by the federal government.
